PRELIMINARY ENGINEERING ASSESSMENT

REHABILITATION OF THE LIGHTSHIP NO. 83

Northwest Seaport

OLD TACOMA MARINE INC.

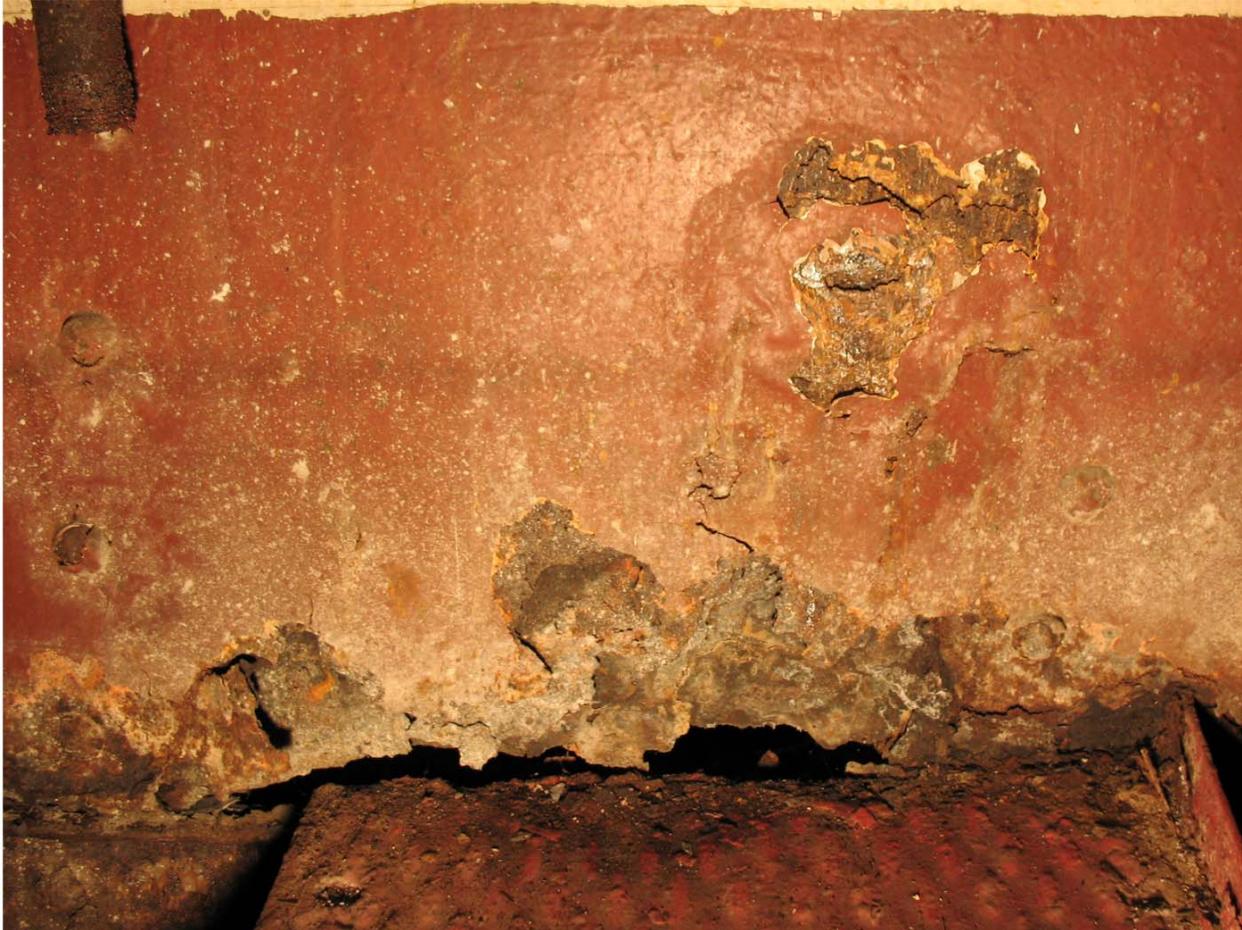
Figure 1: Aft engine room bulkhead before sample needle scaling

OTM Inc selected an area on the aft engine room bulkhead, just behind the ladder access to the workshop space, for sample needle-scaling. The bulkhead showed visible corrosion, but appeared solid beneath damage to the paint.

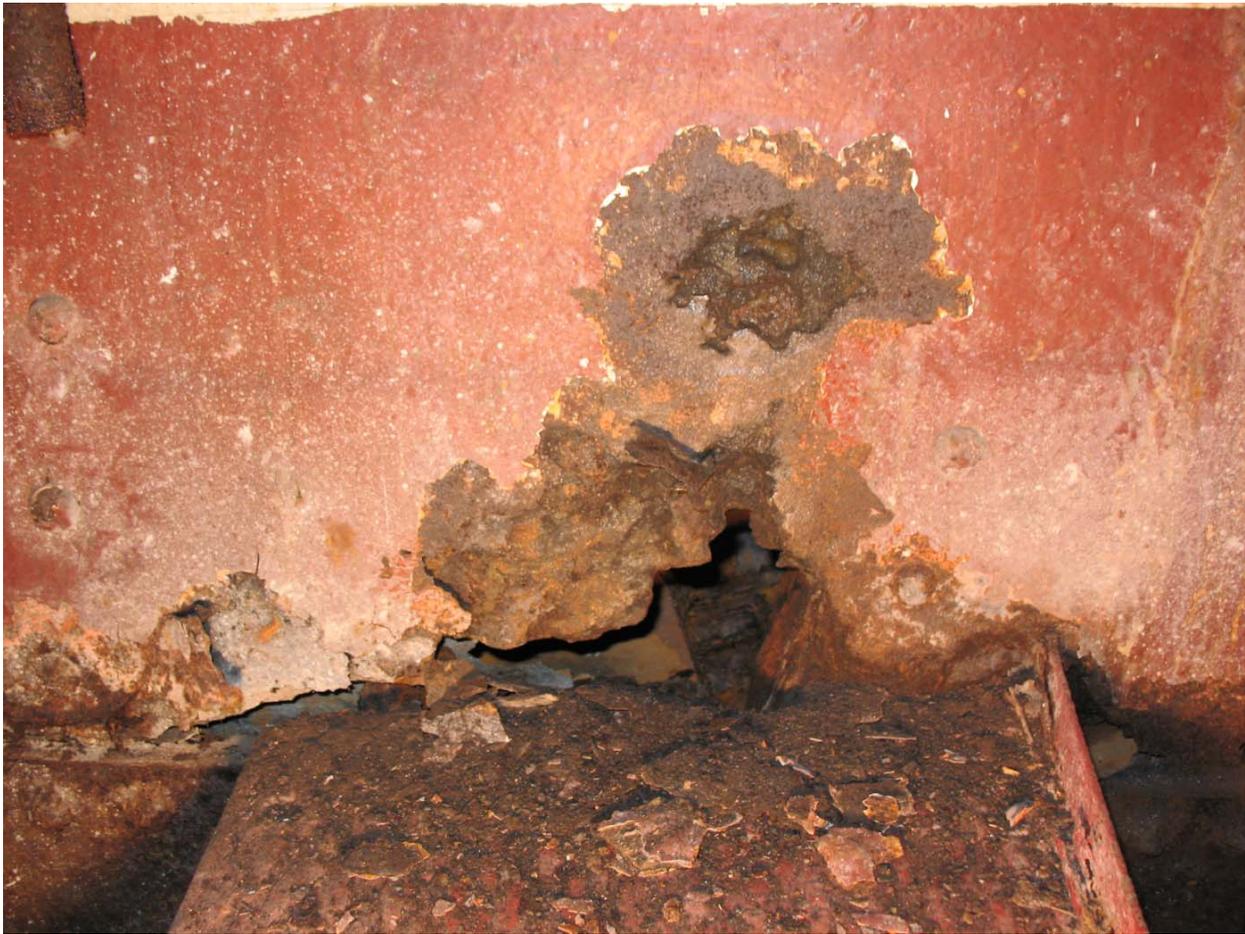
Figure 2: Aft engine room bulkhead after sample needle scaling

OTM Inc discovered through sample needle-scaling this area that the corrosion extended beneath the surface of the bulkhead and that damage to the metal was more extensive than visible before needle-scaling. However, after removing the corrosion with the needle-scaler, the remaining metal seemed in good condition.

As the water pooling in the Lightship No. 83 is attacking the vessel's hull in the same manner as its bulkheads, this demonstrates that while portions of the hull may be in poor condition, there are likely far larger portions that are in good condition and can be patched, following the systematic system used on the tugboat *Maris Pearl*.
